## **APE Quick Guide to Checking Hoses**

Although the examples that follow may not cover every aspect of hoses on a APE Vibro, it is a simple guide to ensure hose quality for normal piledriving operations.

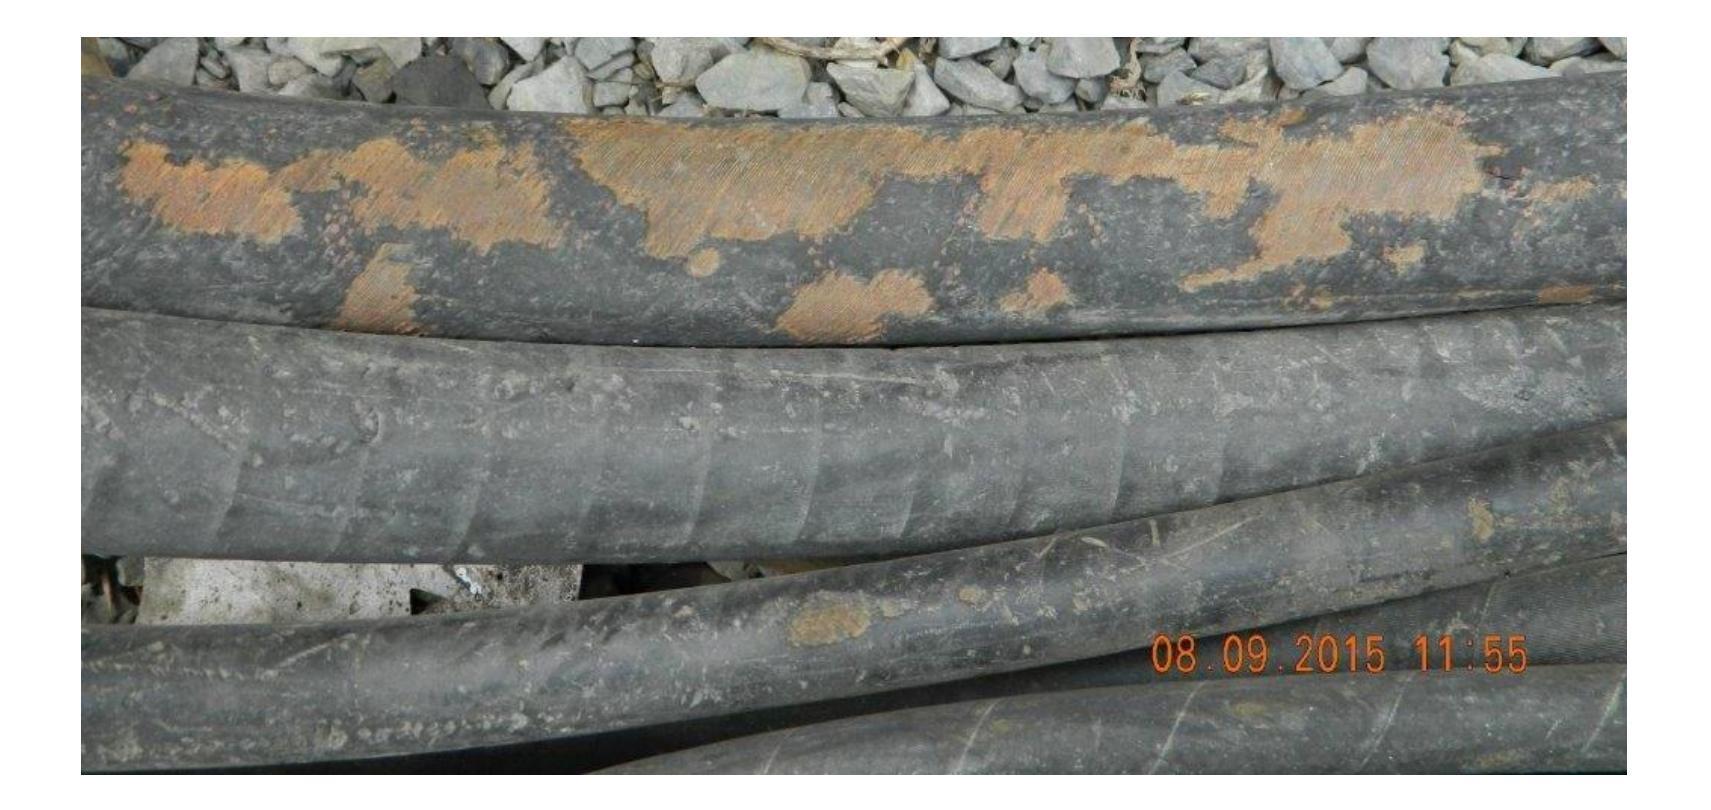
Keeping the hoses from snags and drags across the deck is an important part of ensuring that the hoses will stay in good working order. Although the outer rubber is scaved off of the below hose, this hose is still in good working order. Note that there are no broken wires, or õwhiskersö that indicate a potential failure.

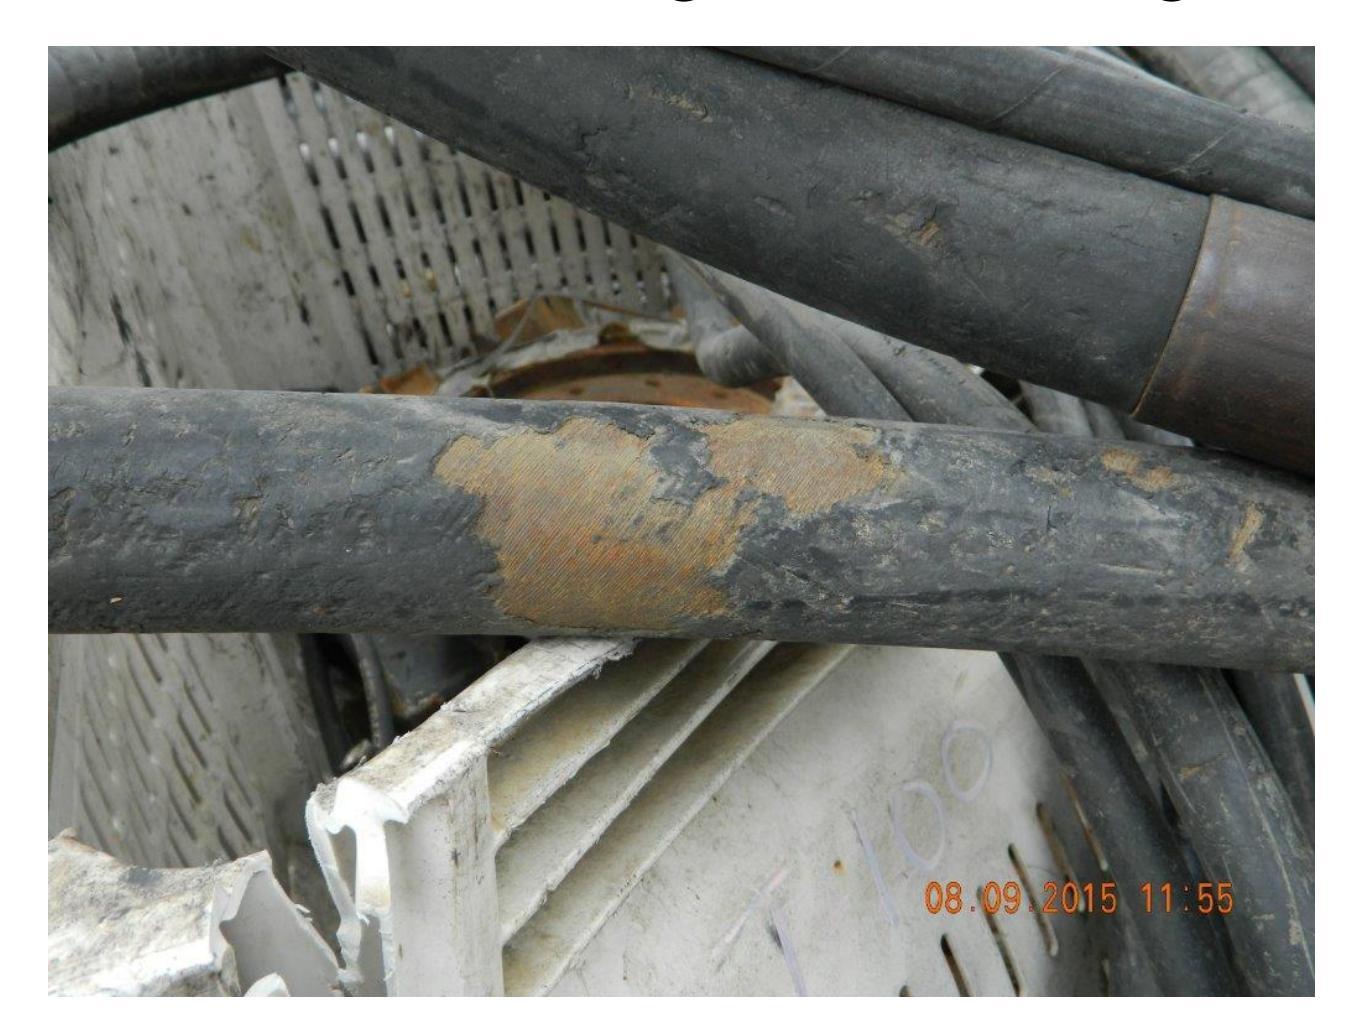
## Another example of a serviceable hose. This hose is still in good working order.

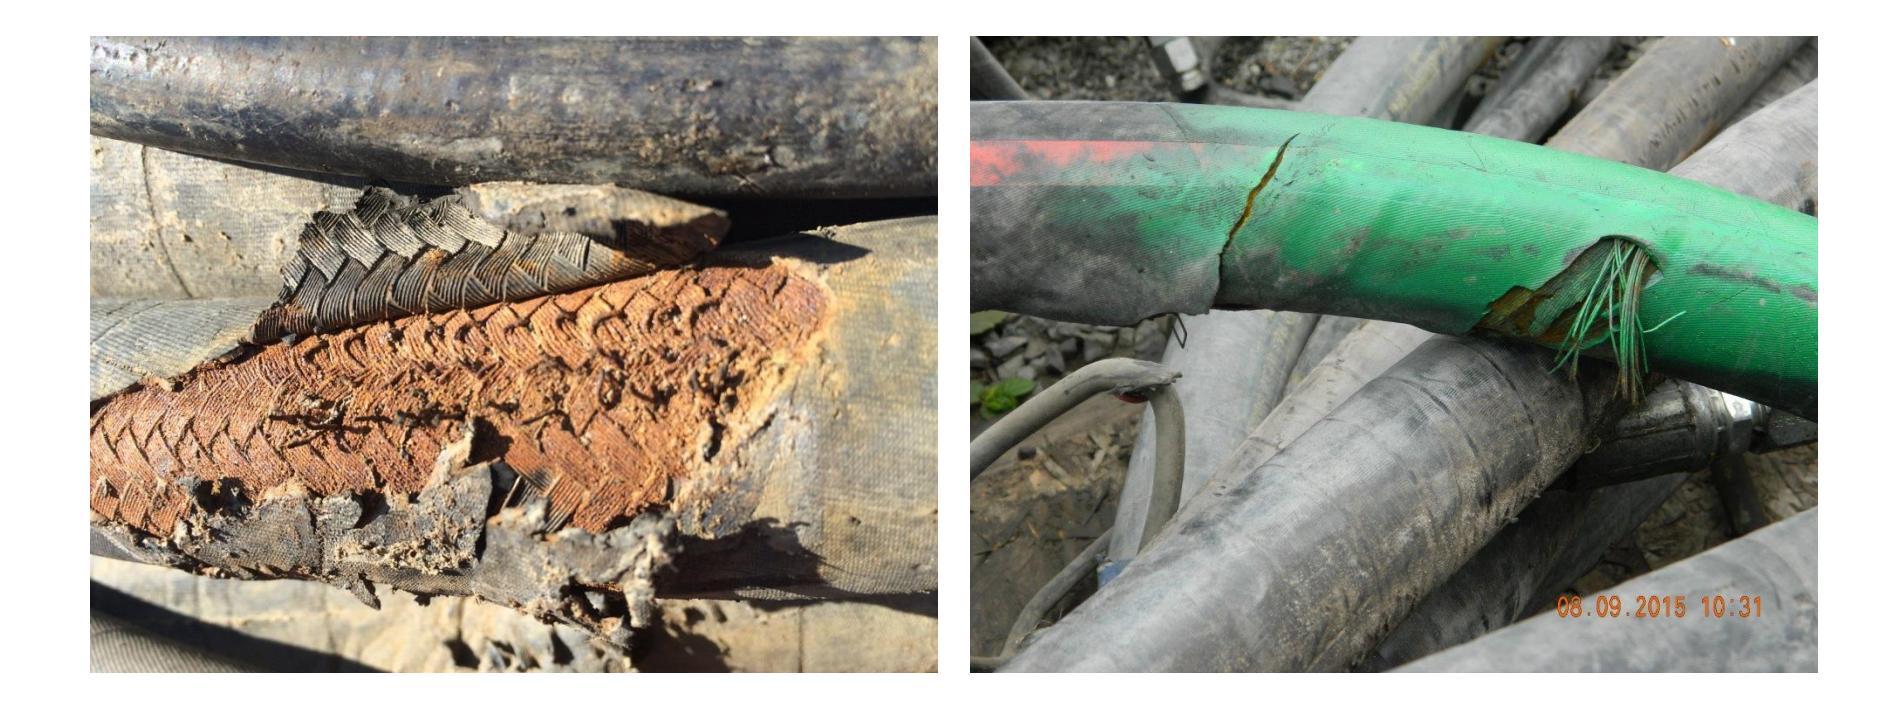
Below examples shows õBADö hoses and should be replaced as soon as possible. These are õHigh Riskö hoses and should not be used.

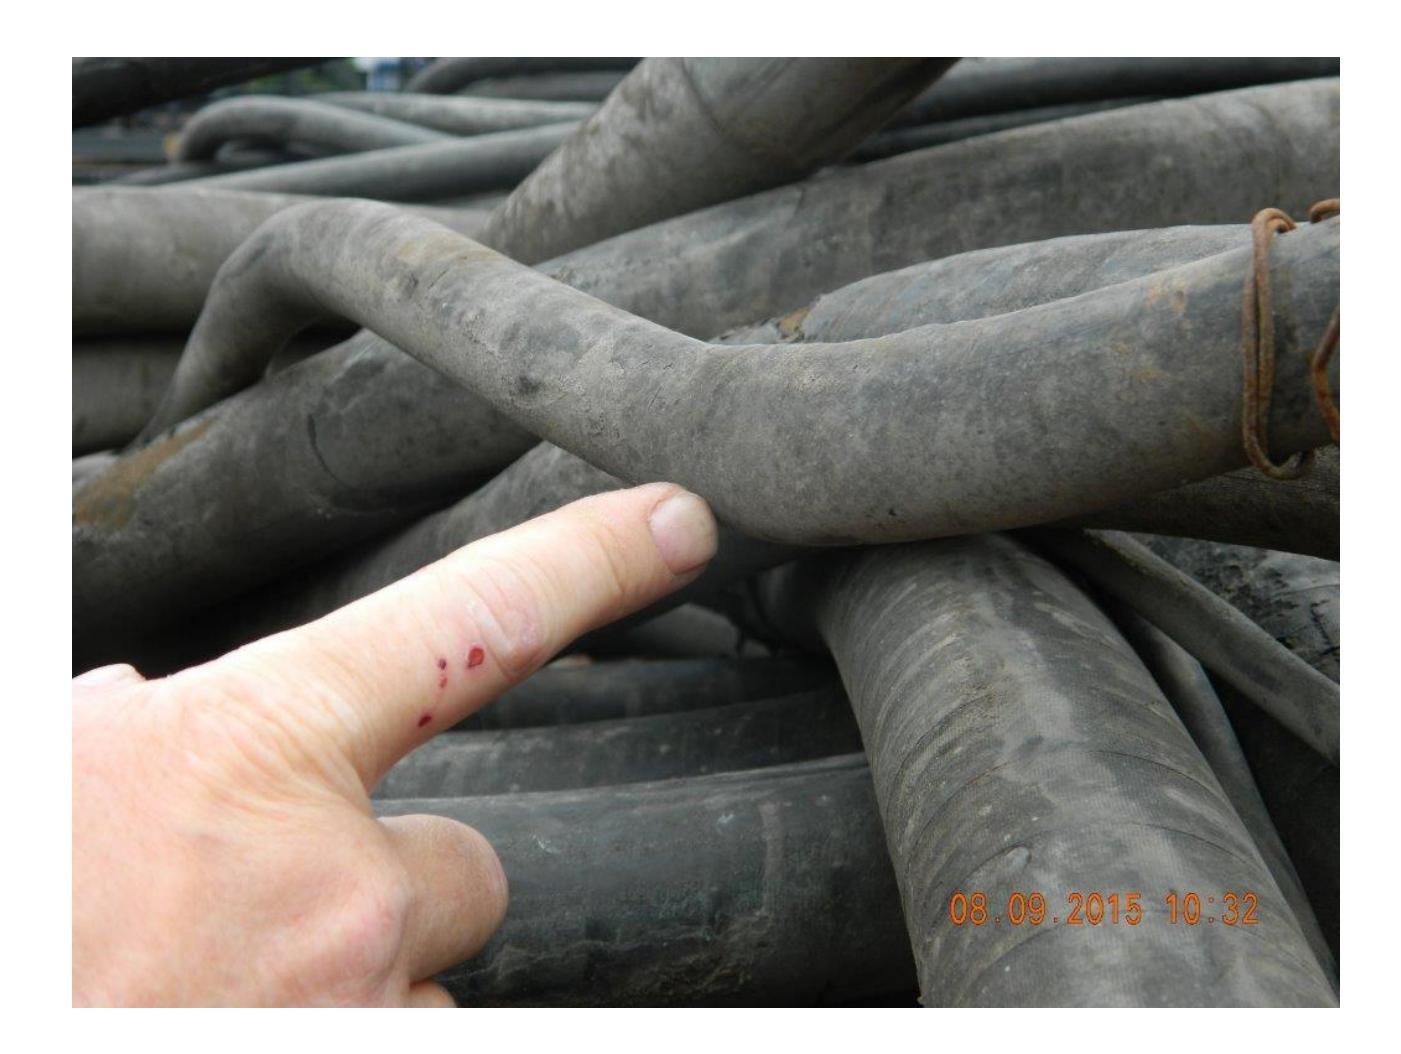
A kink in the hose is a bad hose. Kinks should not be ignored because under outer rubber coating the wire braids may be compromised.

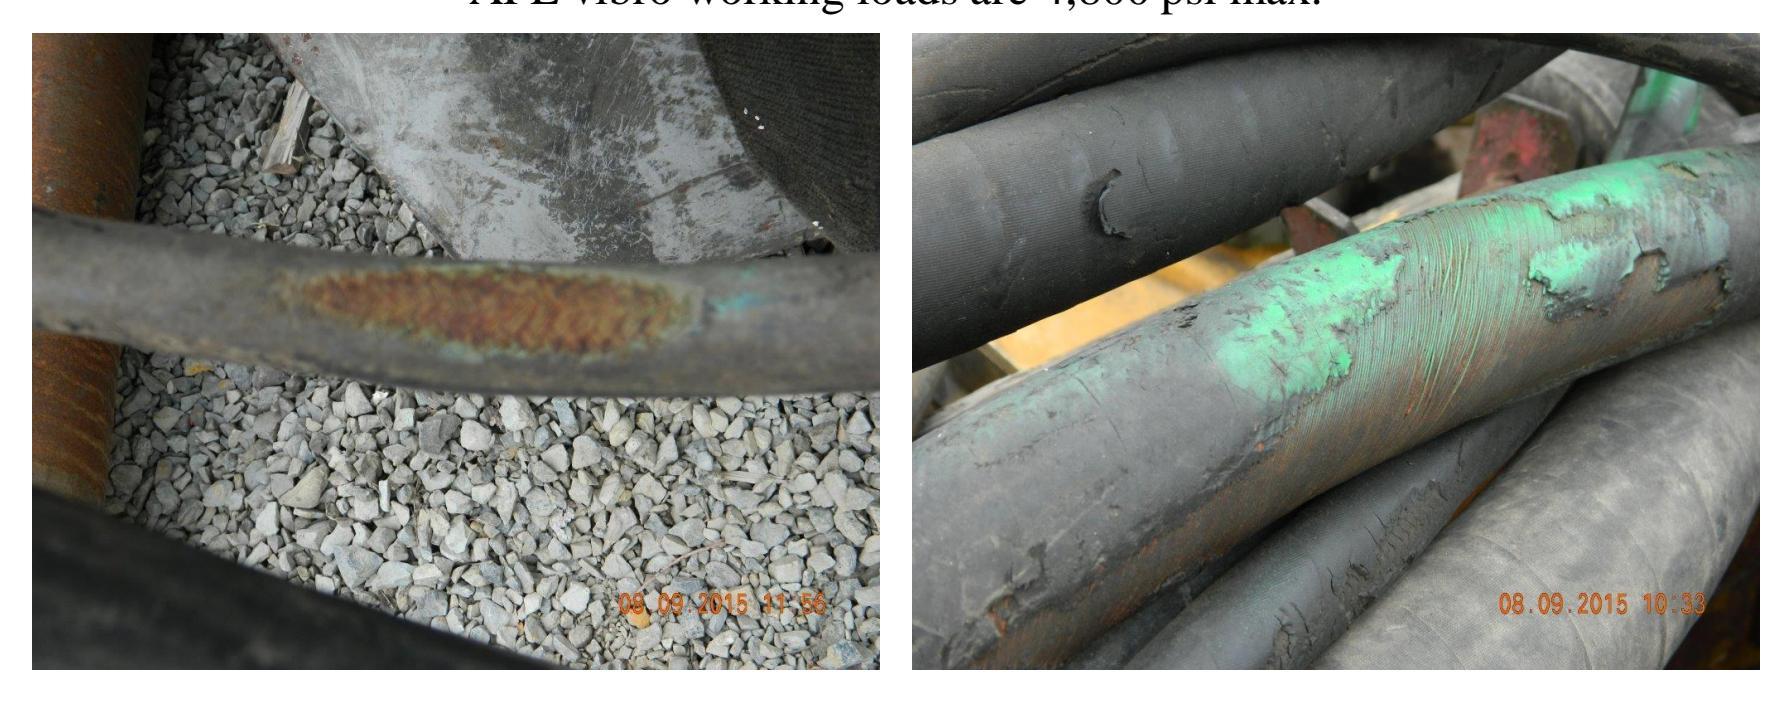
The hose below on the left shows no broken wires or whiskers, but with the deep rust content showing could be a sign of future failure. This hose, although still serviceable, should be changed as soon as possible.

The hose on the right, marked with green paint, has a few broken whiskers but is still servable and can be used to finish out the shift. This hose should be changed between shifts. Note that these high pressure hoses are a six braid hose with a working pressure of 5,000 psi and a 4 to 1 safety factor, or a 20,000 psi burst rating. APE vibro working loads are 4,800 psi max.

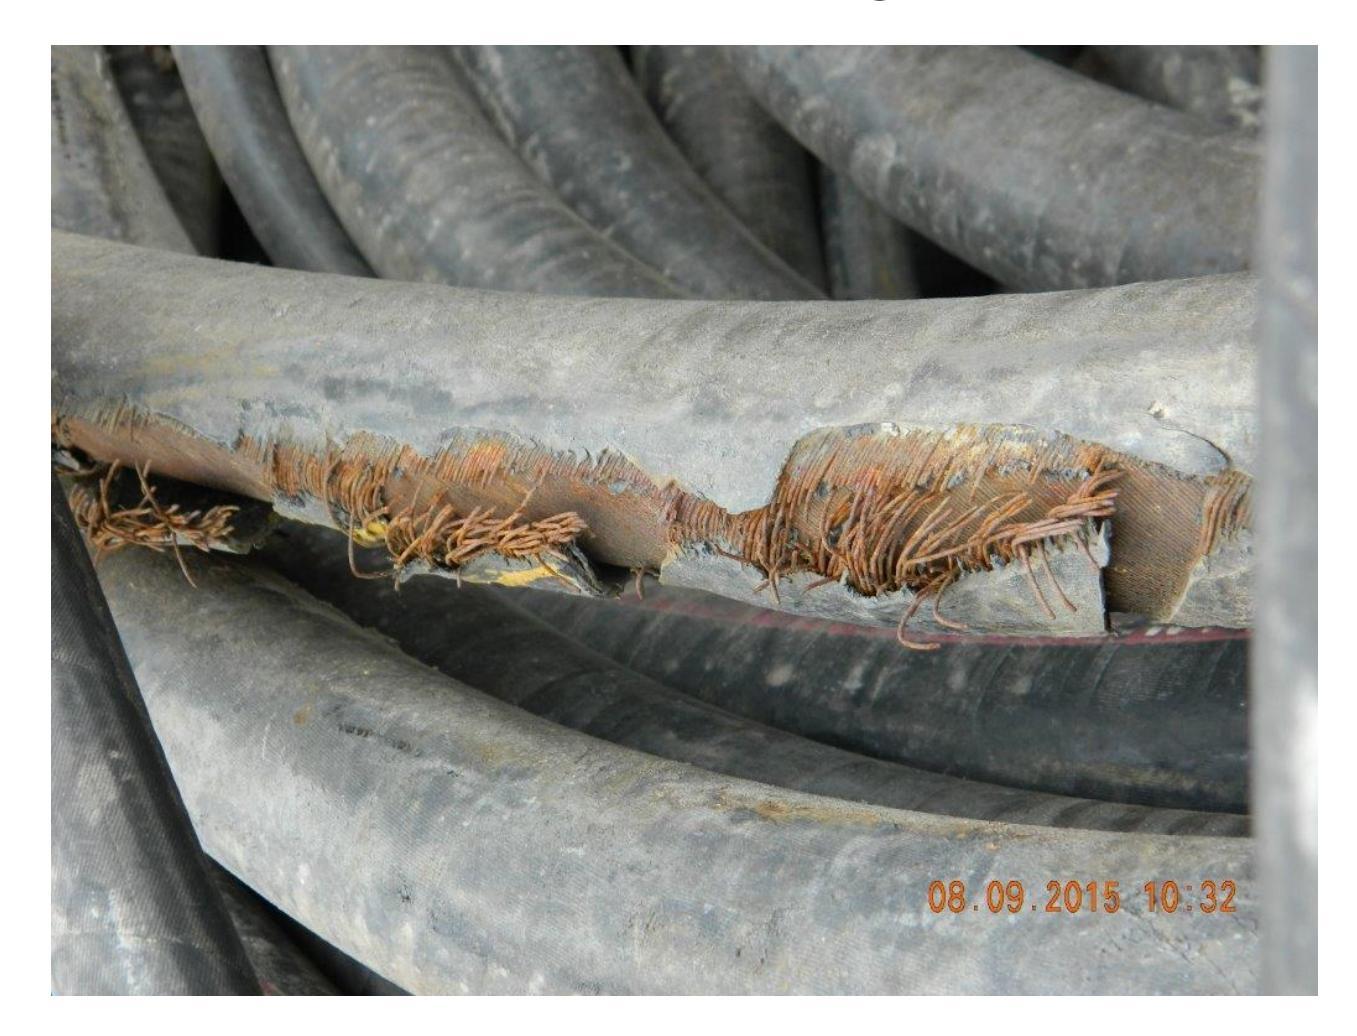
## Multiple broken braids in the hose, like the one below, should be changed immediately.

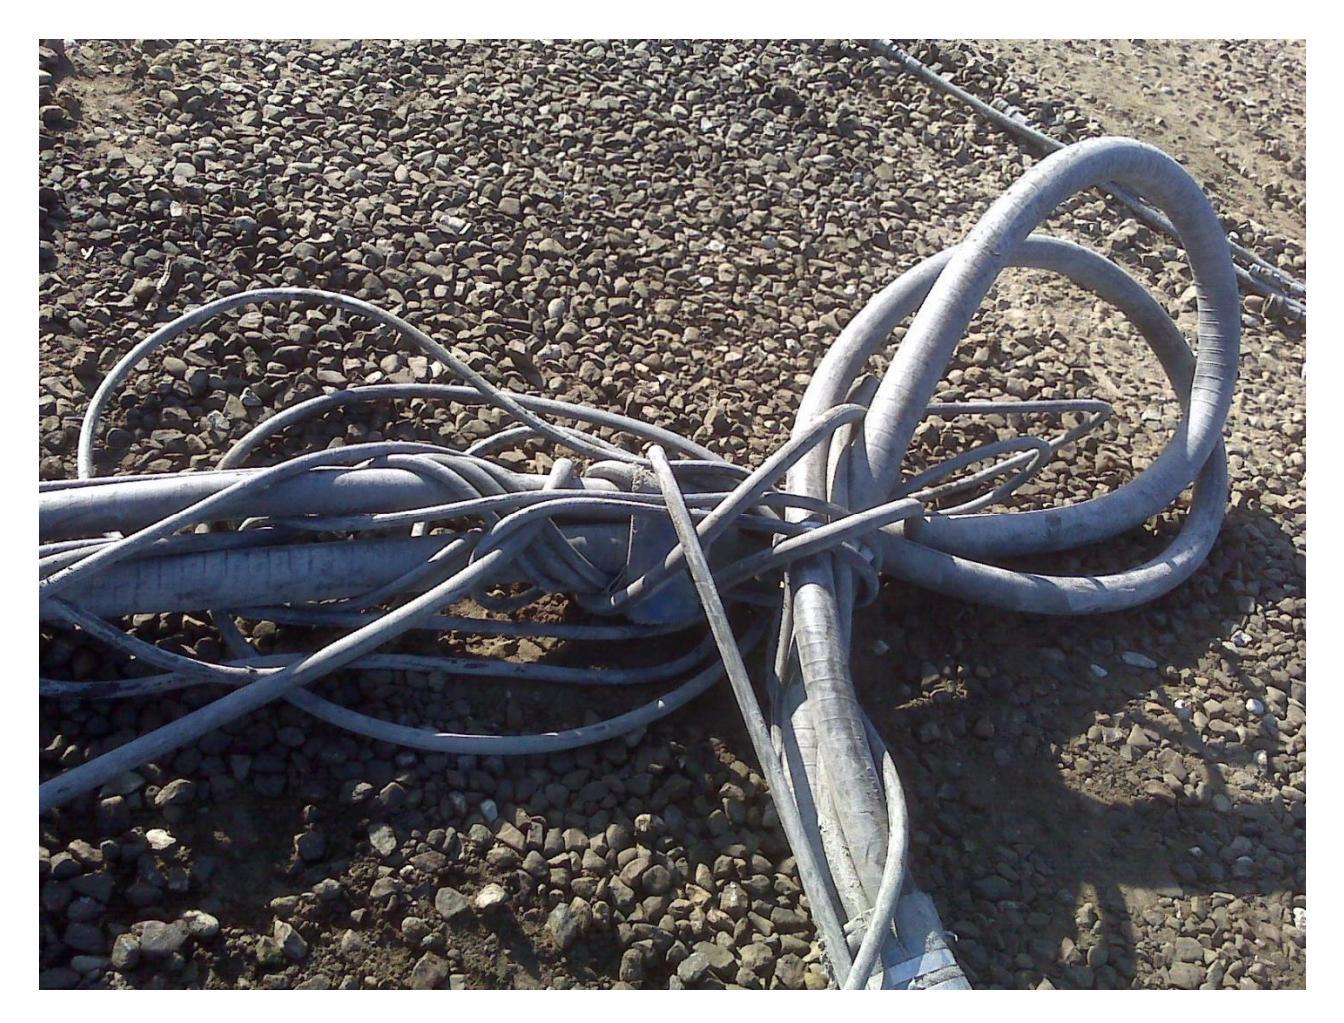
## Stay away from knots that could damage hoses due to kinks.
